[Docket No. FAA–2008–1207; Directorate Identifier 2007–NE–47–AD; Amendment 39–15880; AD 2009–08–07]

Airworthiness Directives; Honeywell International Inc. ALF502L–2 and ALF502L–2C Turbofan Engines

SUMMARY: The FAA is adopting a new airworthiness directive (AD) for Honeywell International Inc. ALF502L–2 and ALF502L–2C turbofan engines with certain high-pressure compressor (HPC) first stage discs installed. This AD requires performing a dimensional inspection to determine if excessive disc balance material was removed and a magnetic particle inspection if the disc

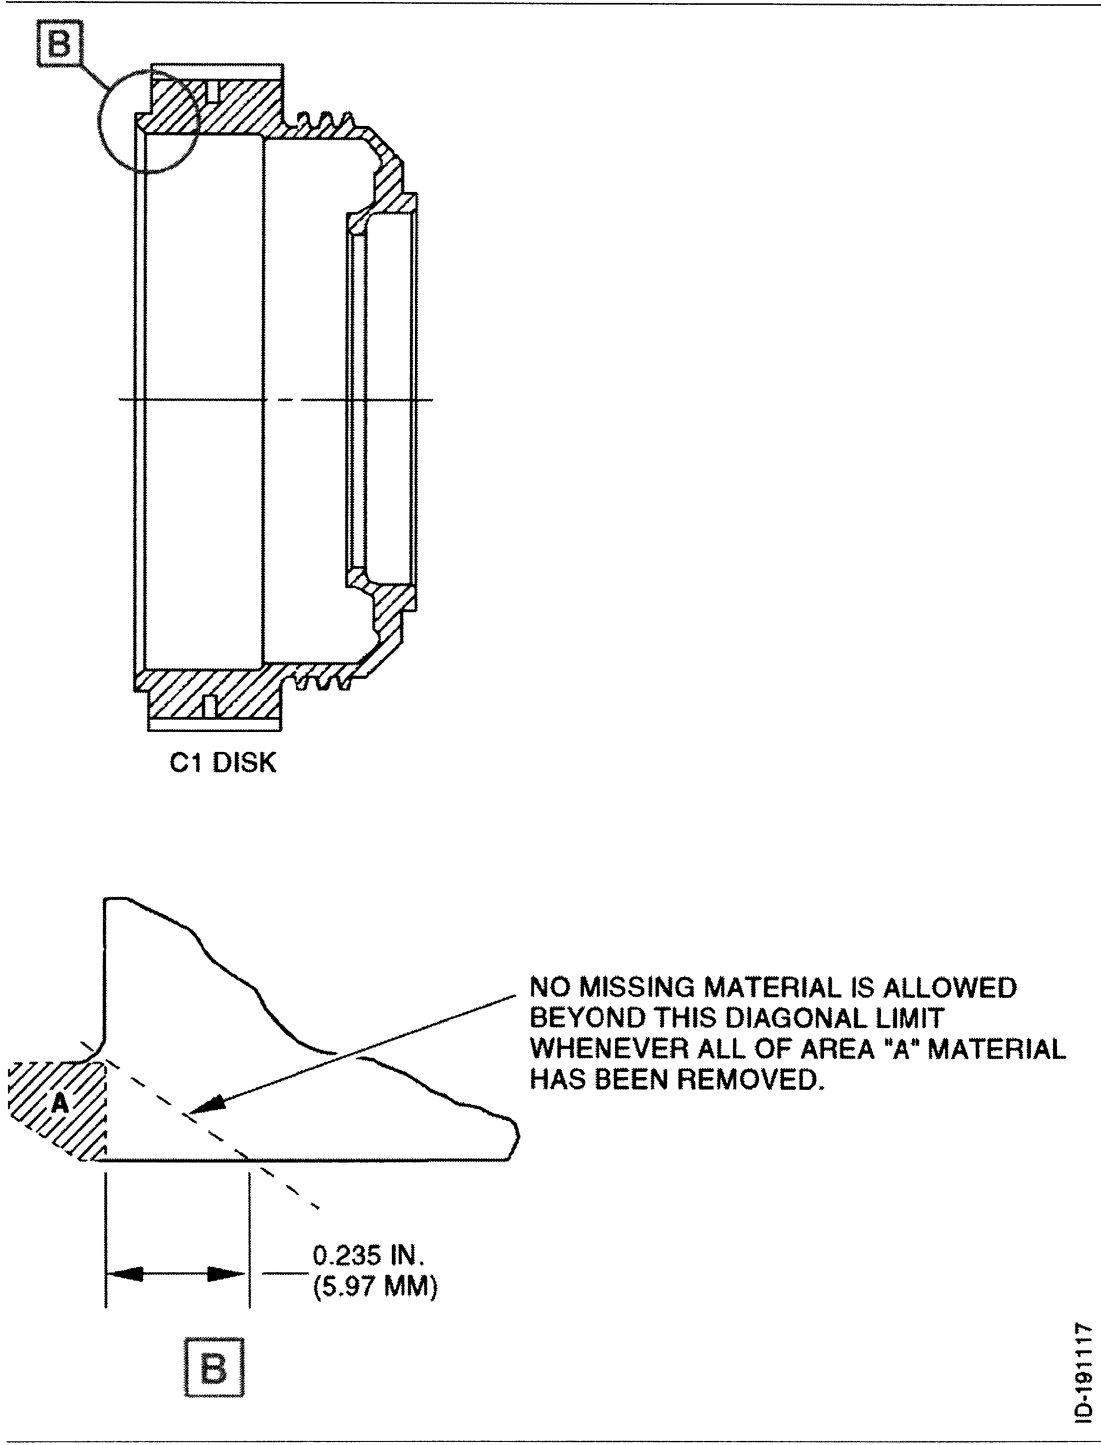
Limits for Removed Balance Material, Disc Forward Flange
Figure 1 (Sheet 1 of 2)

(f) For discs with 5,000 or more cycles-since-new on the effective date of this AD, perform a dimensional inspection of the HPC first stage disc to determine if excessive disc

balance material was removed. See the following Figure 1 for limits.

(g) Replace the disc if excessive disc balance material was removed. See limits in Figure 1 of this AD.

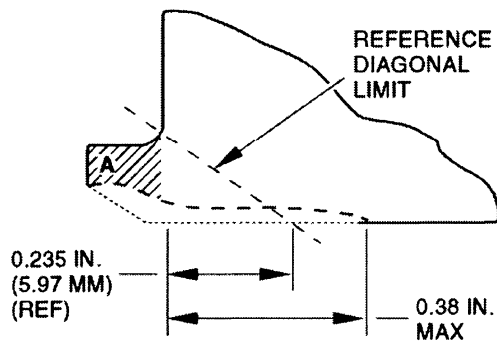
Any remaining Area 'A' lip material is sufficient to permit axial material removal up to 0.38 inch (0.97 mm) limit. Surface shall have a smooth contour and 0.020 inch (0.51 mm) minimum blend radius.

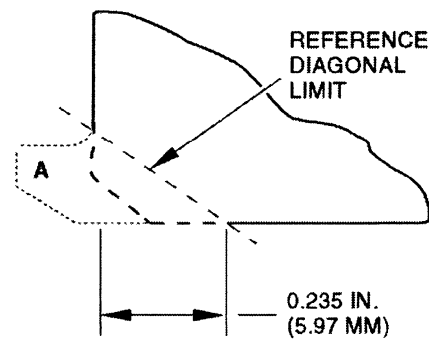
Removal of all Area 'A' material is permitted when axial material removal is less than 0.235 inch (5.97 mm) diagonal limit. Surface shall have a smooth contour and 0.020 inch (0.51 mm) minimum blend radius.

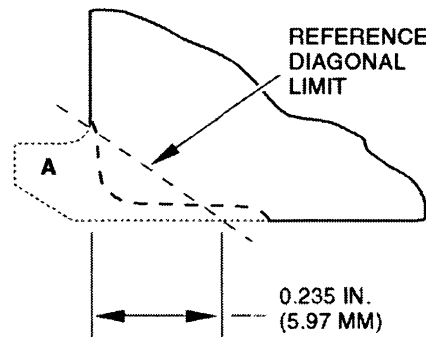
No Area 'A' material remaining and 0.235 inch (5.97 mm) diagonal limit is exceeded.
