[Docket No. FAA-2010-1045; Directorate Identifier 2010-NM-101-AD]

Airworthiness Directives; Airbus Model A318, A319, A320, and A321 Series Airplanes

ACTION: Notice of proposed rulemaking (NPRM).

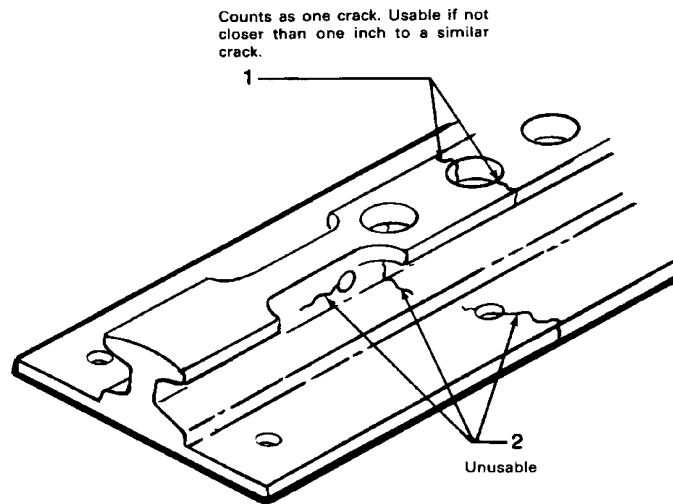
Figure 5. Seat rail

- (1) Any portion of web or lower flange is cracked (index 2).
- (2) Any crack in crown of rail is in any direction other than right angle to length of rail.
- (3) Number of cracks on any one rail exceeds four, or any two cracks (index 1) are closer than one inch.

Use of seat rail cargo tie-downs is not permissible on seat rails with cracks.

REPLACE SEAT RAIL WHEN:

- (10) Reinstall the seat on the seat rail.
- (i) Lift the seat into the airplane and place on the seat rail.
- (ii) Hold seat latch disengaged and slide the seat aft and then forward to re-engage rollers.
- (iii) Lower vertical adjusting seats to a comfortable height.
- (iv) Reattach seat belt/shoulder harness to the seat, if previously attached to the seat.
- (v) Reinstall the seat stops.
