[Docket No. FAA-2007-28661; Directorate Identifier 2007-NM-013-AD]

Airworthiness Directives; The Boeing Company Model 737-600, -700, -700C, -800, and -900 Series Airplanes

ACTION: Supplemental notice of proposed rulemaking (NPRM); reopening of comment period.

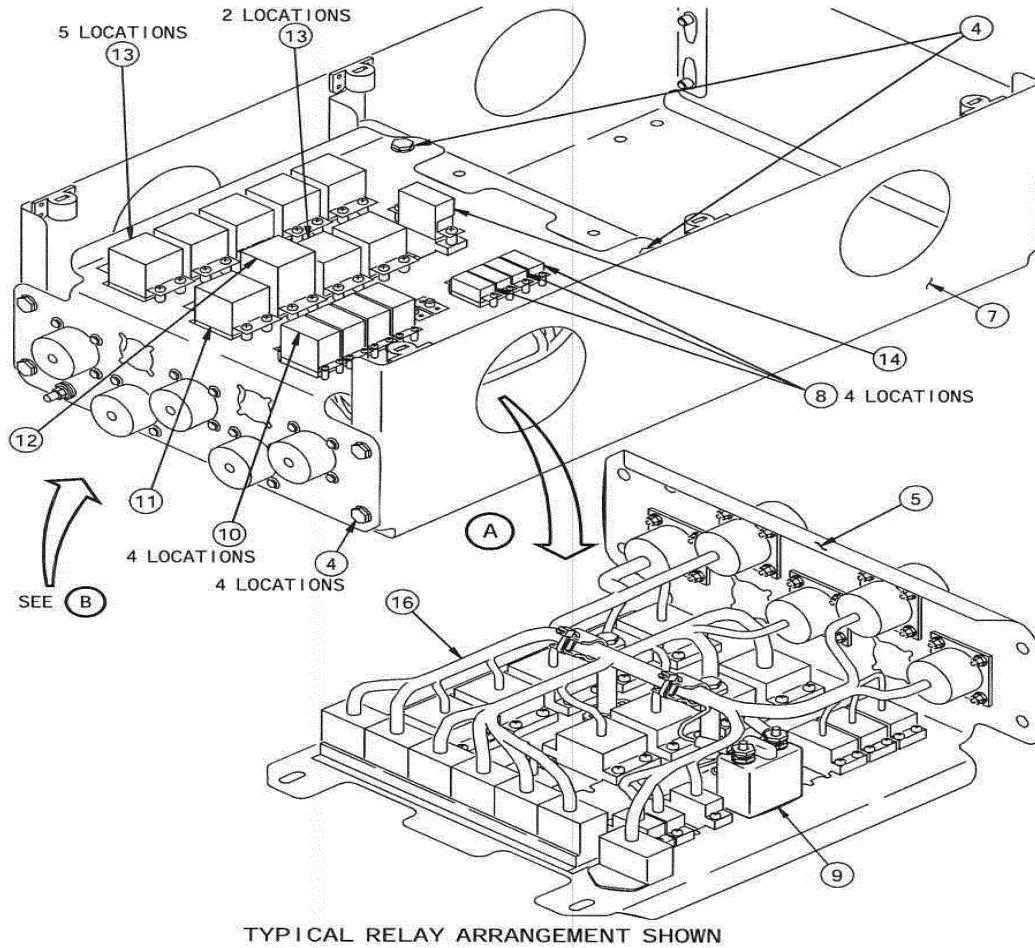
- Sheet 2 of 4 of Figure 11 of Boeing Alert Service Bulletin 737-28A1206, Revision 2, dated May 21, 2009, was inadvertently replaced with Sheet 2 of 4 of Figure 11 from Boeing Alert Service Bulletin 737-28A1206, dated January 11, 2006. That figure was corrected in Boeing Alert Service Bulletin 737-28A1206, Revision 1, dated January 30,

2008, and did not need to be changed in Boeing Alert Service Bulletin 737-28A1206, Revision 2, dated May 21, 2009. We have added Figure 1 in this supplemental NPRM to provide the correct Sheet 2 of 4 of Figure 11.
