[Docket No. FAA-2010-0342; Directorate Identifier 2002-NE-08-AD; Amendment 39-16458; AD 2010-20-23]

Airworthiness Directives; Bombardier-Rotax GmbH Type 912 F, 912 S, and 914 F Series Reciprocating Engines

ACTION: Final rule.

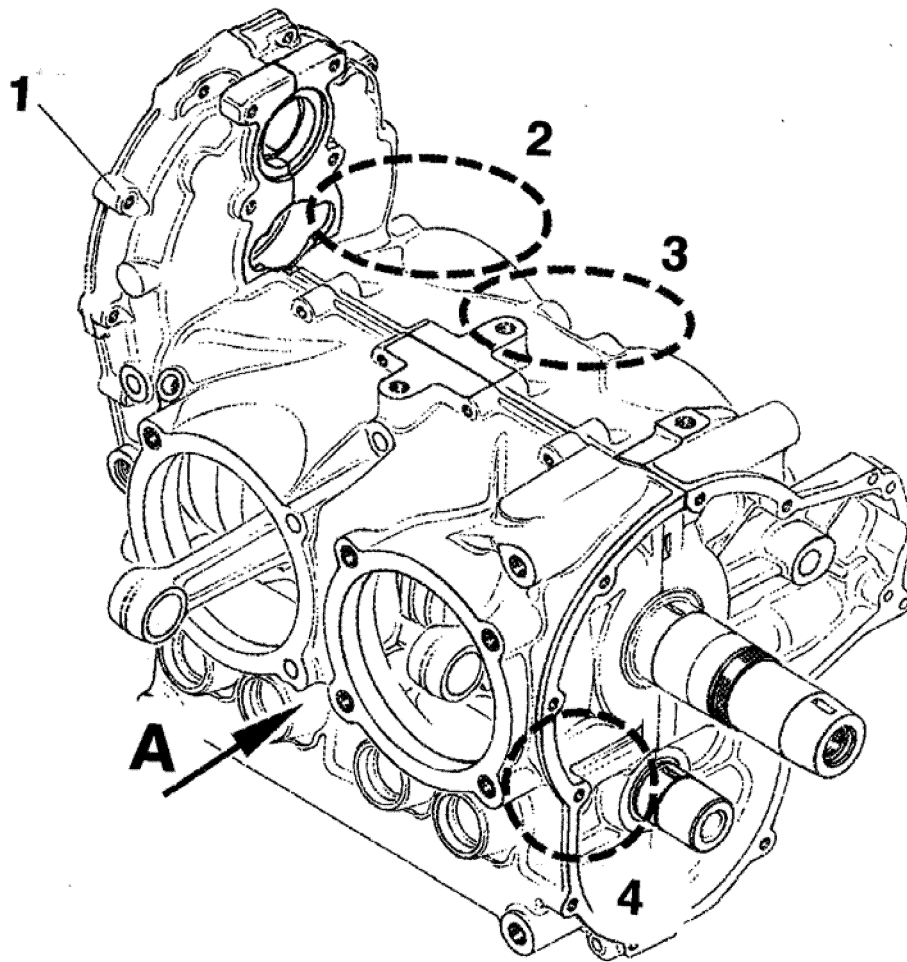
Figure 1. Engine Crankcase Inspection Areas

- (1) Inspect the engine crankcase (item 1, Figure 1 of this AD) for cracks especially in the area of cylinder 1 upper side (item 2), between cylinder 1 and 3 upper side (item 3), cylinder 4 lower-right side (item 4) and detailed inspection in the area identified in Figure 2 (item 5) of this AD. Information concerning this inspection can be found in Bombardier-Rotax Mandatory Service Bulletins No. SB–912–029, Revision 3, dated July 11, 2006 and No. SB–914–018, Revision 3, dated July 11, 2006.

(2) Cracks in crankcases of engines with a ROTAX cooling air baffle may not be easily visible, and oil leaks may be an indication of cracks. Visually inspect for oil leaks in areas of cylinder 1 upper side (item 2, Figure 1 of this AD) and between cylinder 1 and cylinder 3 upper side (item 3).

(4) If the engine crankcase is cracked, remove the engine from service before further flight.

(h) Visually inspect the engine crankcase (item 1, Figure 1 of this AD) for cracks at each 100-hour, annual, or progressive inspection, or within 110 hours TIS since last inspection, whichever occurs first, in accordance with paragraphs (g)(1) through (g)(4) of this AD.
